**Case Study #1: Paint Bake Oven Upgrades/Performance Enhancement**

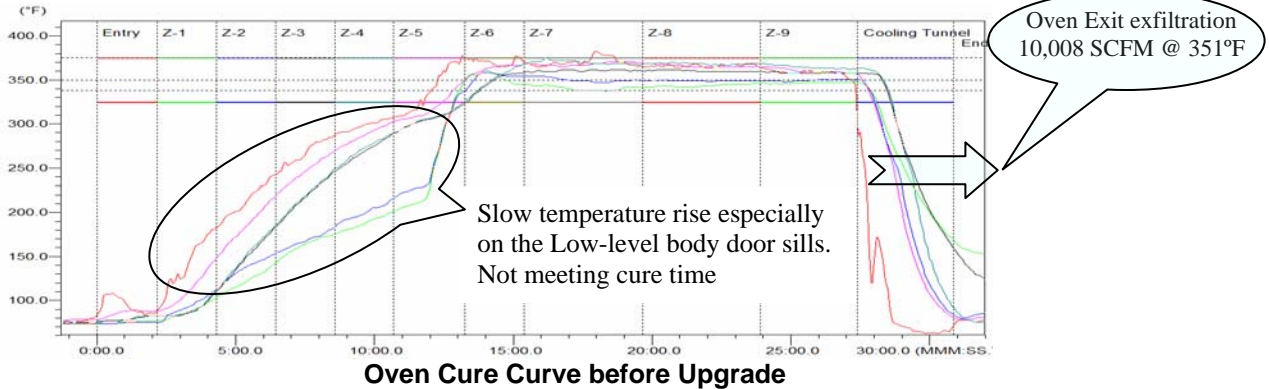
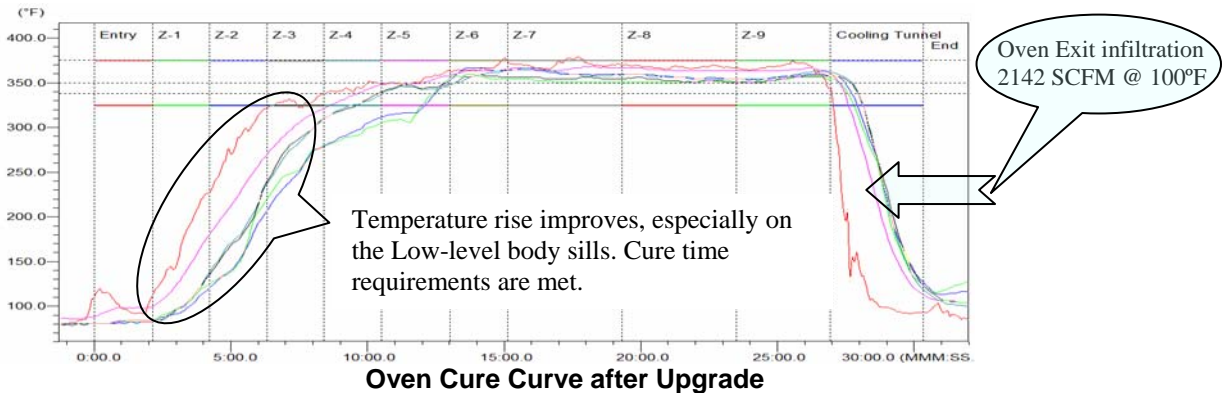
1. Repaired oven exit air seal, increased exhaust volume, oven is negative and is no longer spilling hot air and reduce gas usage.
2. Modified sill duct, to increase the amount of heated fresh air on the low level door sills which increased the temperature rise and met the specifications.
3. Extended zones 5 and 7 low-level supply nozzles to further increase the low level body temperature and insure proper cure.

In addition to improving the cure of the sills, the solution resulted in a reduction of 7,800 CFM of fresh air supply to the oven resulting in \$105,418 annual savings from natural gas with the cost of implementation of the solution at \$ 125,880. **ROI in 14 months!**
